An Evaluation of Different Material Line Insulators under High Voltage AC and Bipolar DC Excitation in a Marine Polluted Environment

by
Gerton Nicolaas Jacobus Mouton

*Thesis presented in partial fulfilment of the requirements for the degree
Master of Science in Engineering at Stellenbosch University*

December 2012

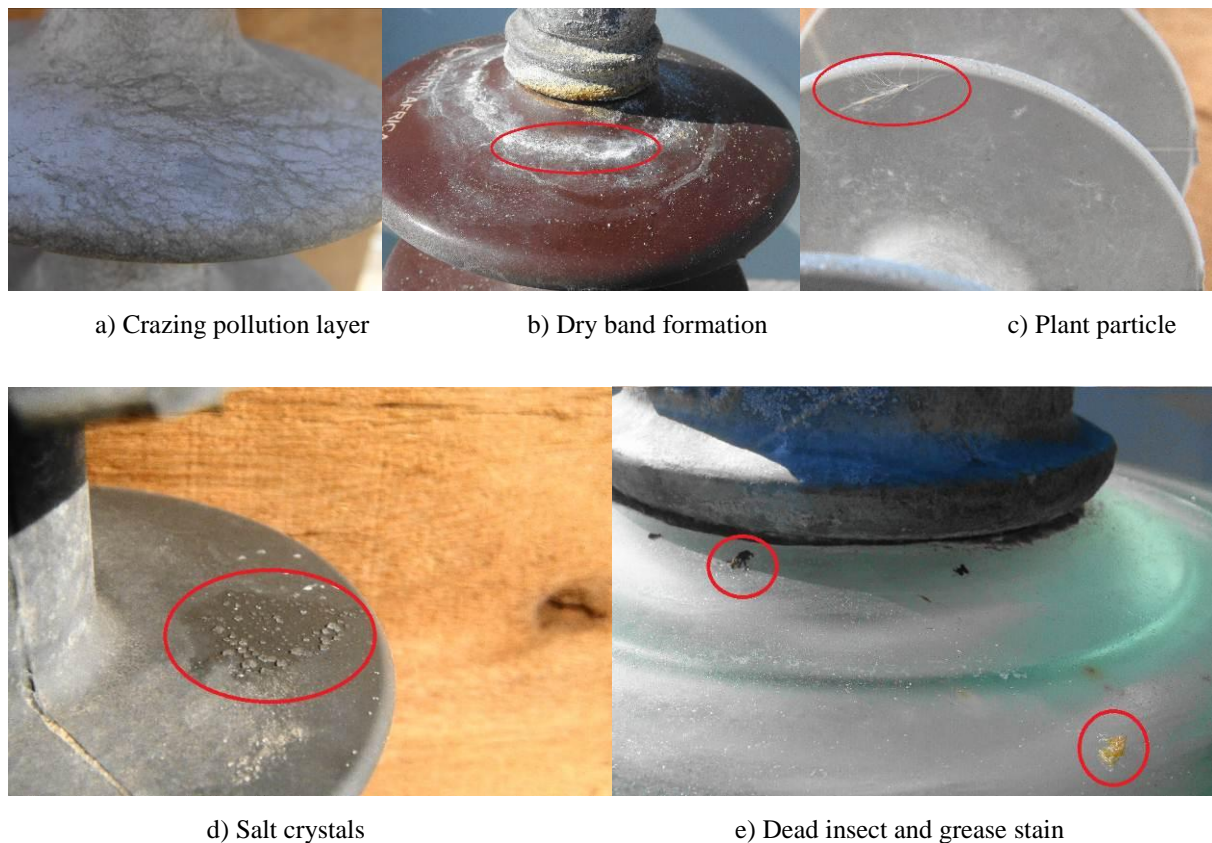
Figure 5-9: Photographs of observations not directly considered during evaluations

Please refer to Figure 5-9 for photographs of the other observations that were not directly considered during the insulators surface performance evaluations.

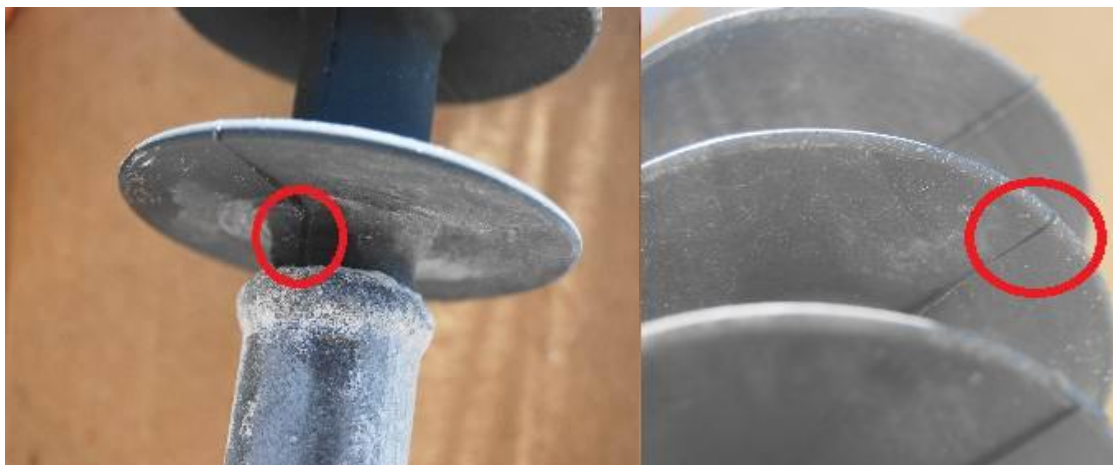
Figure 5-11: Light erosion observations on mould line of the AC_EPDM insulator

It is evident from Table 5-7 that light erosion observations were more prominent on the mould lines, the east side of the insulator and close to the earthed side of the insulator. Furthermore, it is noted that all of the light erosion observations were preceded by light pollution and dry band formations. The dry band formations are indicative that there were electrical discharge activities at the respective areas and it could be the cause of material erosion. Please refer to Figure 5-10 and Figure 5-11 for photographs of light erosion observations on AC_EPDM insulator.

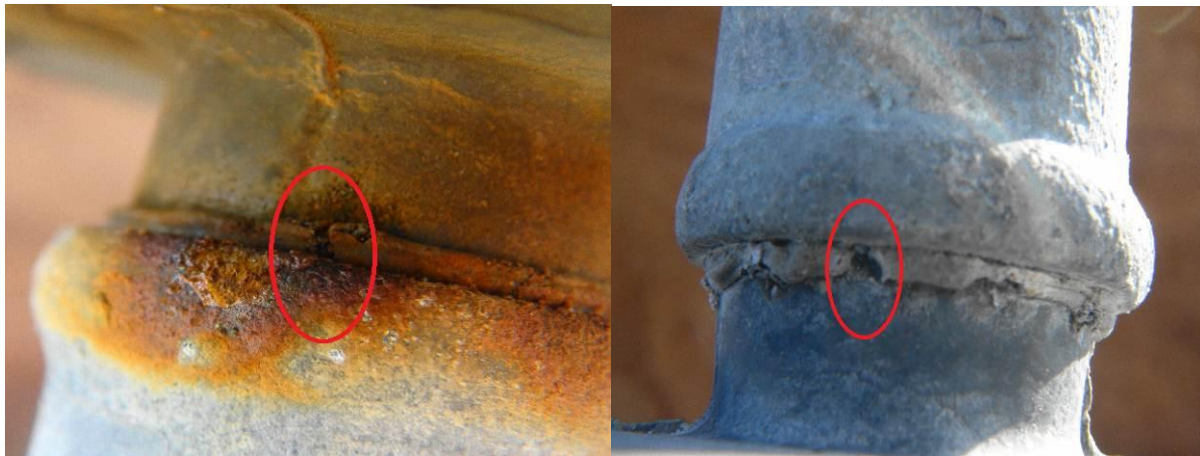
Figure 5-15: Erosion observations on sealant of the DC+_EPDM insulator

The details of first occurrences of light erosion and erosion are summarized in Table 5-10, where the erosion observations were limited to the end fitting sealant. Furthermore, it is noted that the light erosion observations were more prominent on the mould lines, the middle axial section of the insulator and the east and west side of the insulator. It is also noted that most of the light erosion and erosion observations were preceded by light pollution and dry band formations. The dry band observations are indicative that there were electrical discharge activities at the respective areas and it could be the cause of material erosion. Please refer to Figure 5-14 and up to Figure 5-17 for photographs of light erosion and erosion observations on the DC+_EPDM insulator.

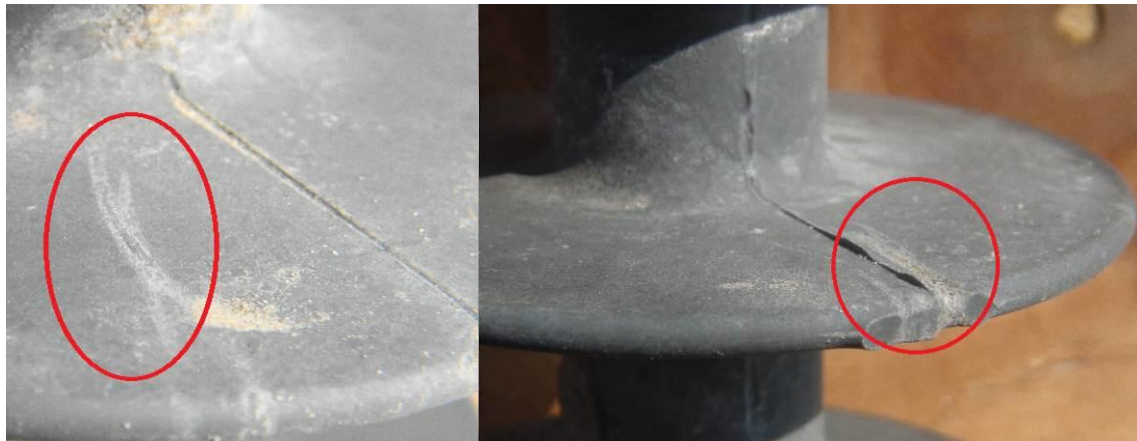
Figure 5-17: Light erosion observations on the shed tops of the DC+_EPDM insulator

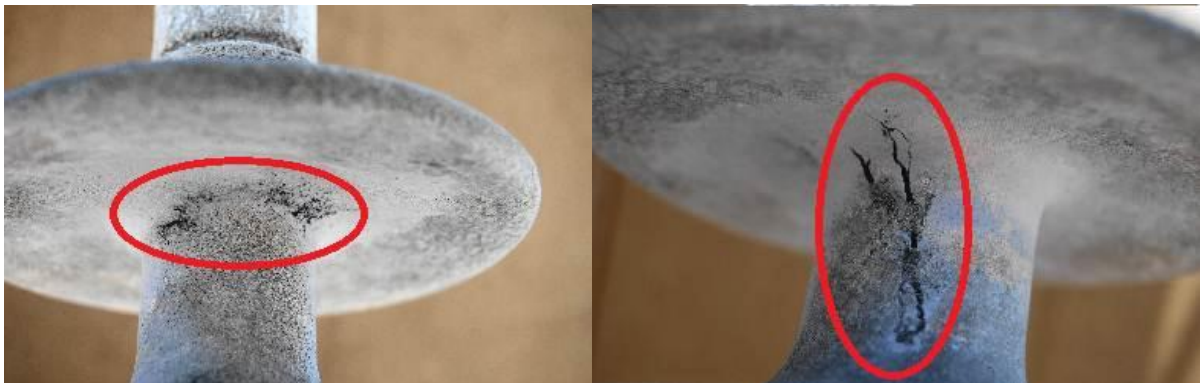
It is evident from Table 5-12 that the light erosion and erosion observations were more prominent on the sheath section, the south side of the insulator and close to the earthed side of the insulator. Furthermore, it is noted that most of the light erosion and erosion observations were preceded by medium pollution, dry band formation, crazing within the pollution layer and colour change activities. The colour change activities are also considered as a material degradation observation. Dry band and colour change observations are indicative that there were electrical discharge activities at the respective areas and this could be the cause of

material erosion. Please refer to Figure 5-19 and Figure 5-20 for photographs of erosion observations on the DC+_RTV insulator.

Figure 5-20: Erosion observations on the sheaths of the DC+_RTV insulator

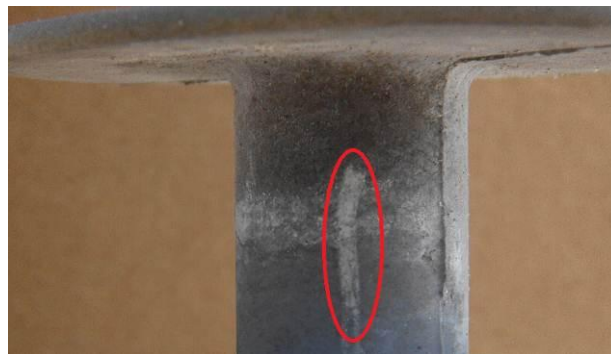
From the above table it is noted that the light erosion observations are more prominent on the sheath sections, the south side of the insulator and close to the live end fitting of the insulator. It is also noted that most of the light erosion and erosion observations were preceded by light pollution and dry band formation observations. The dry band formations are indicative that there were electrical discharge activities at the respective areas and this could be the cause of material erosion. Please refer to Figure 5-25 and Figure 5-26 for photographs of light erosion and erosion observations on DC-_HTV insulator.

Figure 5-26: Light erosion observation on sheath on the DC-HTV insulator

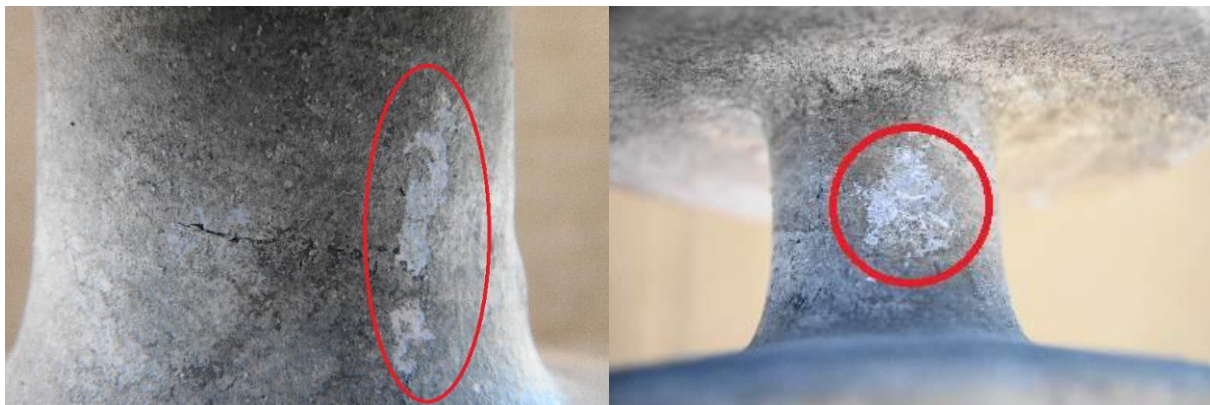
From the observations listed in Table 5-16, the observation on shed 1 bottom, which was observed on 19 May 2011, and the observation on shed top 3, which was observed on 1 December 2011, are erosion observations. The other observations are light erosion observations, which are more prominent on the sheath sections of the insulator. Furthermore, the light erosion and erosion observations are more prominent on the south side of the insulator and close to the live end fitting of the insulator. It is also noted that most of the light erosion and erosion observations were preceded by light pollution, dry band formation, crazing within the pollution layer and colour change observations. A colour change activity in itself is also a sign of material degradation. The dry band and colour change observations are indicative that there were electrical discharge activities at the respective areas and this could be the cause of material erosion. Please refer to Figure 5-27 and Figure 5-28 for photographs of light erosion and erosion observations on the DC-_RTV insulator.

Figure 5-28: Light erosion observations on the DC-_RTV insulator

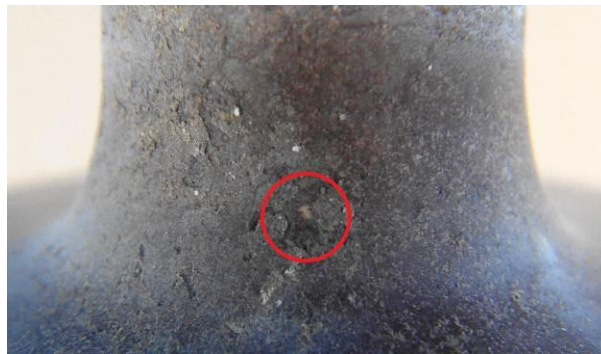
As seen in Table 5-17, the light erosion occurred on the sheath section, south direction and it was preceded by medium pollution, dry band and salt crystal observations. The light erosion was observed close to the live end fitting of the insulator. The dry band formation is indicative that there were electrical discharge activities present at the respective area and this could be the cause of material erosion. Please refer to Figure 5-27 for a photograph of the light erosion observation on the DC-_Porcelain insulator.

**Figure 5-29: Light erosion observation on the DC-_Porcelain insulator**

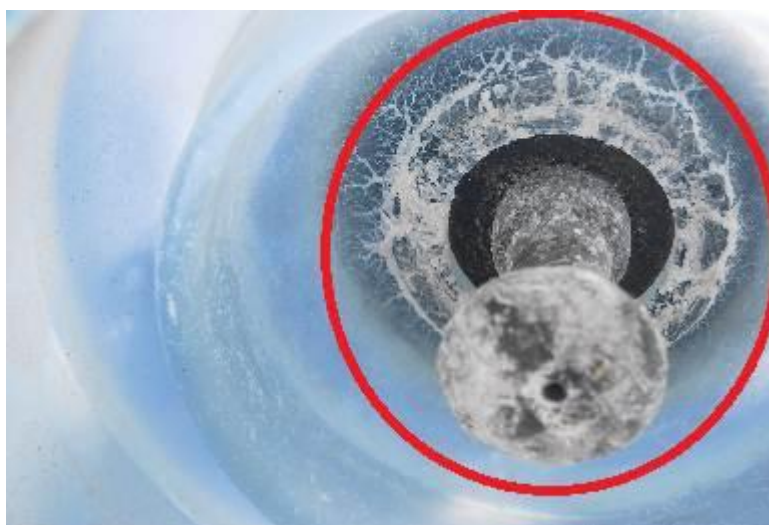
It is evident from Table 5-18 and Figure 5-30 that glass erosion observations were more prominent around the pin area on the bottom side of the insulator. As seen in Figure 5-30, there was no cement growth or swelling of the pin, which could have put a mechanical force on the glass disc leading to the glass erosion forming. Thus, it may be assumed that the glass erosion was caused by electrical discharge activity, as indicated by the dry band formations on the glass disc preceding the glass erosion observation. Please refer to Figure 5-30 for a photograph of glass erosion observation on the DC-₋Glass insulator.

Figure 5-30: Glass erosion observation on the DC-₋Glass insulator

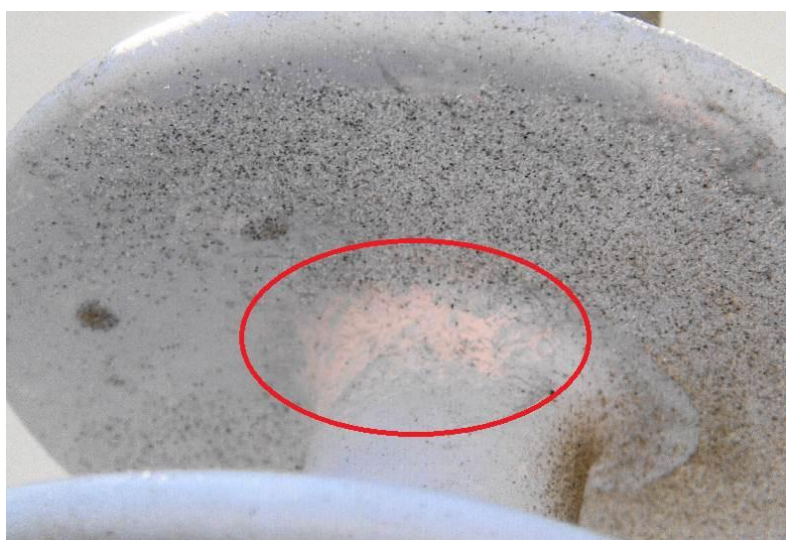
From Table 5-23, it is evident that there is no trend regarding axial position prominence on the insulator. It is also noted that most of the colour change observations were preceded by light pollution and crazing within the pollution layer observations. The dry band formation observations were not as prominent as with the light erosion and erosion observations. It is also noted that the greater majority of the observations were captured during the first two inspection cycles. Please refer to Figure 5-32 for a photograph of colour change observations on the AC_RTV insulator.

Figure 5-32: Colour change observation on the AC_RTV insulator

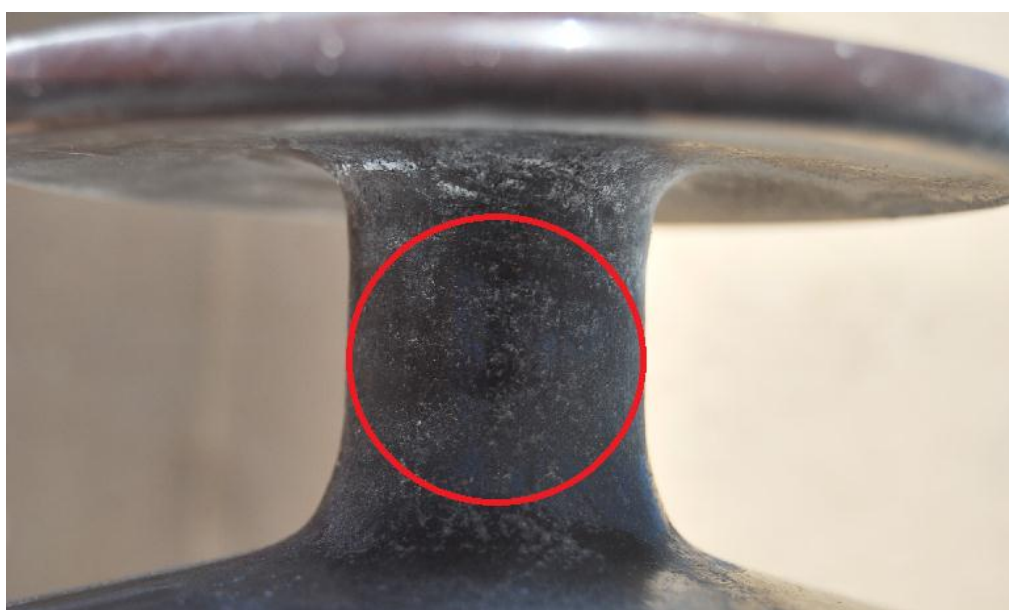
for the chipping of the glazing. Please refer to Figure 5-36 for a photograph of a chipped glazing observation on DC-Porcelain insulator.

Figure 5-36: Chipped glazing observation on DC-Porcelain insulator

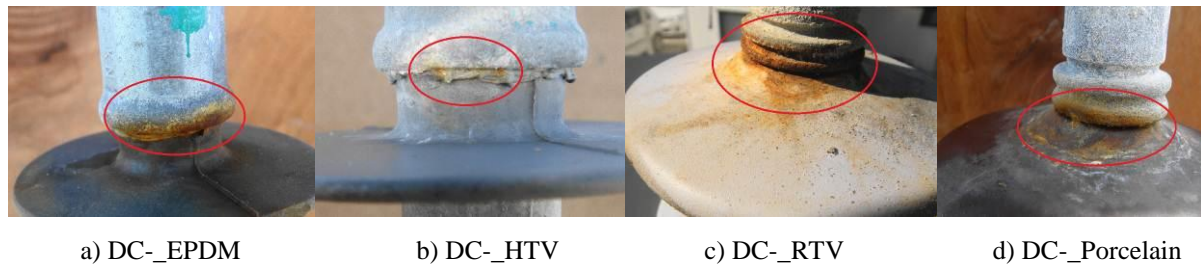
It is evident from Table 5-32 that no corrosion was observed on the metal end fittings of the insulators under AC excitation voltage. However, corrosion was observed on the live metal end fittings of all the insulators under DC+ excitation voltage, except the Glass insulator and corrosion was observed on the earthed metal end fittings of all the insulators under DC- excitation voltage except for the Glass insulator. Thus, corrosion occurred on the metal end fittings which have a relative positive voltage. It is also noted that corrosion on the metal end fittings were first observed on the insulators under DC- excitation voltage. Further, only the HTV insulators on both DC excitation voltages have a light corrosion observation, while the other insulators have moderate corrosion observations. Please refer to Figure 5-37 and Figure 5-38 for photos of the relevant corrosion observations.

Figure 5-37: Corrosion on the earthed metal end fittings of the insulators under DC- excitation voltage

The cause of corrosion of the metal end fittings, with the relative positive voltages, is an electrolytic corrosion process caused by the DC leakage currents. This process is explained in Figure 5-39 where it is illustrated that the metal end fitting with the relative positive voltage donates positive iron ions to the water electrolyte, which consists of the conducting solution layer on the surface of the insulator [57]. The positive iron ions react with hydroxide ions, which were reduced from oxygen and water, to form iron (II) hydroxide which readily undergoes oxidation to form hydrated iron (III) oxide, better known as rust [58].

It appears from the above mentioned results that hot dipped galvanizing does not provide sufficient protection for the metal end fittings against electrolytic corrosion for insulators under DC excitation voltages. A sacrificial zinc sleeve or zinc ring is thus recommended for all metal end fittings of insulators under DC excitation voltages.

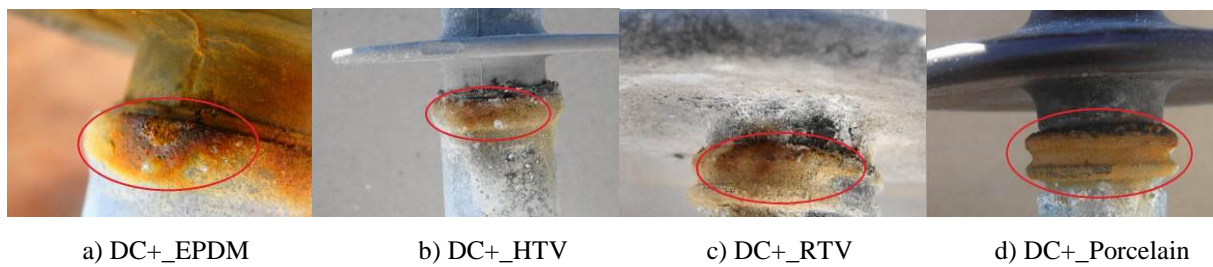
Figure 5-38: Corrosion on the live metal end fittings of the insulators under DC+ excitation voltage

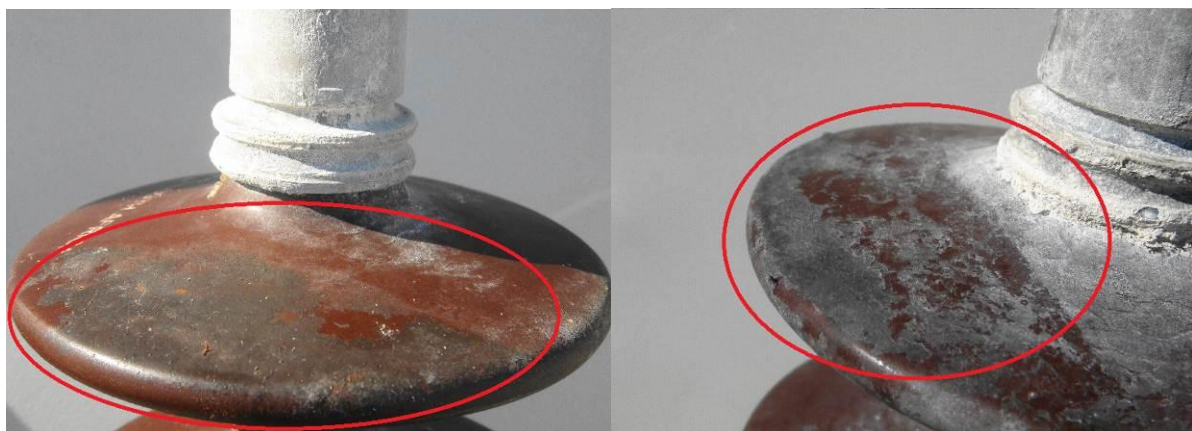
Initially it was thought that the dark layer observations were burned fungus growths on the insulators, but at the end of the research period, samples of the dark layers were sent to a Microbiology laboratory at the University of Stellenbosch, where it was found that it was not a fungus growth. Currently it is not known what had caused the dark layers on the respective porcelain insulators. However, it is known that the dark layer observations were preceded by dry band observations as presented in Table 5-33, which indicate that there were electrical discharge activities at the respective insulator areas. Thus, a substance e.g. pollution, salt crystals, plant particles, grease stain or a combination of it could have been burned by the electrical discharge activities and formed the dark layers.

a) AC_Porcelain insulator

b) DC+_Porcelain insulator

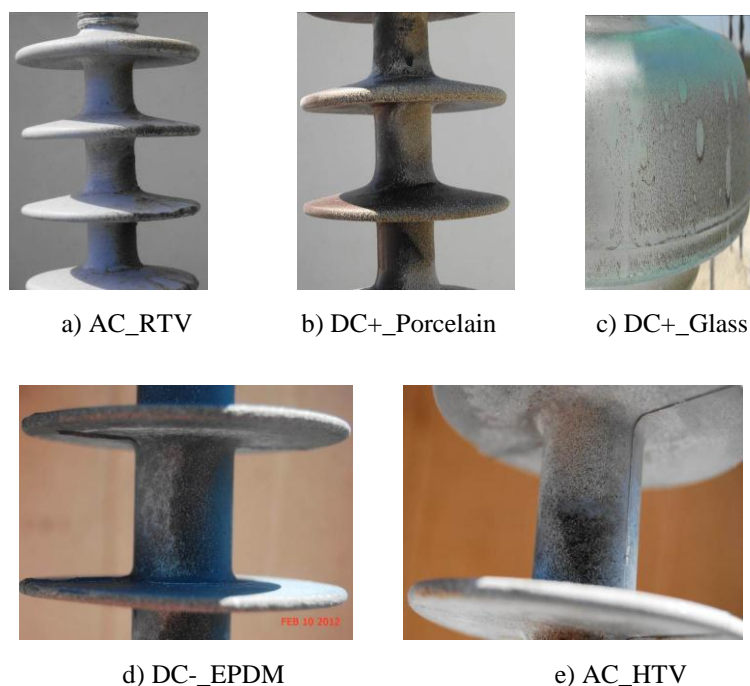
The number of sheaths, shed tops and shed bottoms covered with sand during each inspection were summed per wind direction for each insulator and divided by the total number of sheaths, shed tops and shed bottoms of the respective insulator, in order to obtain the percentage value covered by sand for each wind direction. The corresponding values of all the inspection were summed and divided by the number of inspections, in order to obtain an average value of sand pollution per insulator per direction. These values are tabulated in Table 5-34 and used to evaluate the amount of sand pollution on the insulators. Please refer to Figure 5-42 for photographs of typical sand pollution on the insulator surfaces.

Figure 5-42: Photographs of insulators with sand deposited on their surfaces

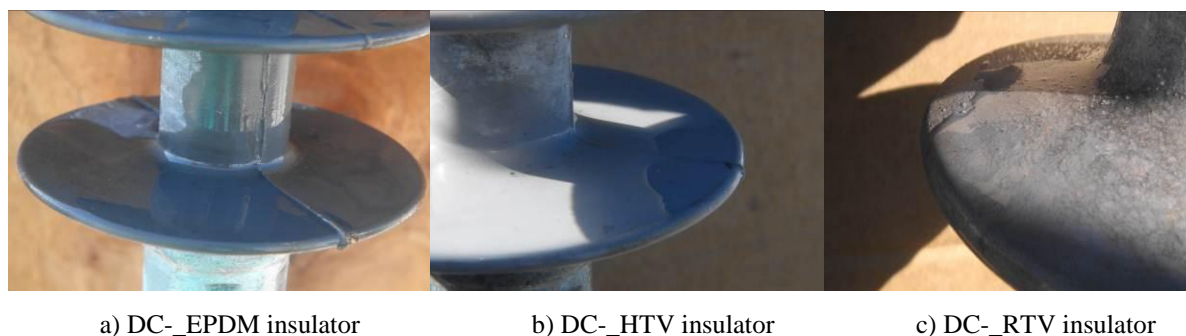
It is evident from Table 5-35 that the DC-EPDM insulator lost its hydrophobicity characteristic the earliest of the insulators under DC- excitation voltage. The EPDM and

HTV insulators were installed on 16 May 2011 on all three different excitation voltage arms. The DC-_{EPDM} insulator surface was hydrophilic by its first inspection cycle, which was conducted on 19 May 2011. The DC-_{HTV} insulator surface was hydrophilic by its third inspection cycle, which was conducted on 5 September 2011. The DC-_{RTV} insulator surface was hydrophilic by its fourth inspection cycle, which was conducted on 19 May 2011. It regained some of its hydrophobicity characteristic by its fifth inspection cycle on 26 July 2011, but lost it again by its sixth inspection cycle on 5 September 2011. It is observed in Figure 5-5 that KIPTS received approximately 115 mm rain between the fourth and fifth inspection cycles of the DC- voltage arm. This amount of rain could have cleaned the DC-_{RTV} insulator surface, which could have led to the regaining of some of its hydrophobicity characteristic. Please refer to Figure 5-43 for photographs of the hydrophilic state of the polymer insulators under DC- excitation voltage.

Figure 5-43: Hydrophilic state of polymer insulators under DC- excitation voltage

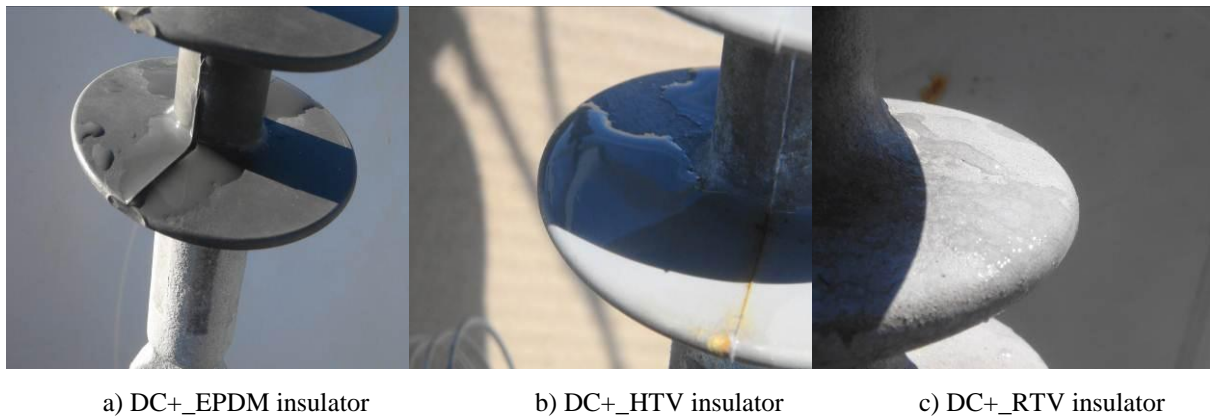
It is evident from Table 5-36 that the DC+_{EPDM} insulator lost its hydrophobicity characteristic the earliest of the polymer insulators under DC+ excitation voltage. The DC+_{EPDM} insulator surface was hydrophilic by its first inspection cycle, which was conducted on 7 June 2011. The DC+_{HTV} insulator surface was hydrophilic by its third inspection cycle, which was conducted on 26 October 2011. The DC+_{RTV} insulator surface was hydrophilic by its third inspection cycle, which was conducted on 19 April 2011. It regained some of its hydrophobicity characteristic by its fourth inspection cycle on 7 June 2011, but lost it again by its sixth inspection cycle on 26 October 2011. It is observed in Figure 5-5 that KIPTS received approximately 70 mm rain between the third and fourth inspection cycles of the DC+ voltage arm. This amount of rain could have cleaned the DC+_{RTV} insulator surface, which could have led to the regaining of some of its hydrophobicity characteristic. Please refer to Figure 5-44 for photographs of the hydrophilic state of the polymer insulators under DC+ excitation voltage.

Figure 5-44: Hydrophilic state of polymer insulators under DC+ excitation voltage

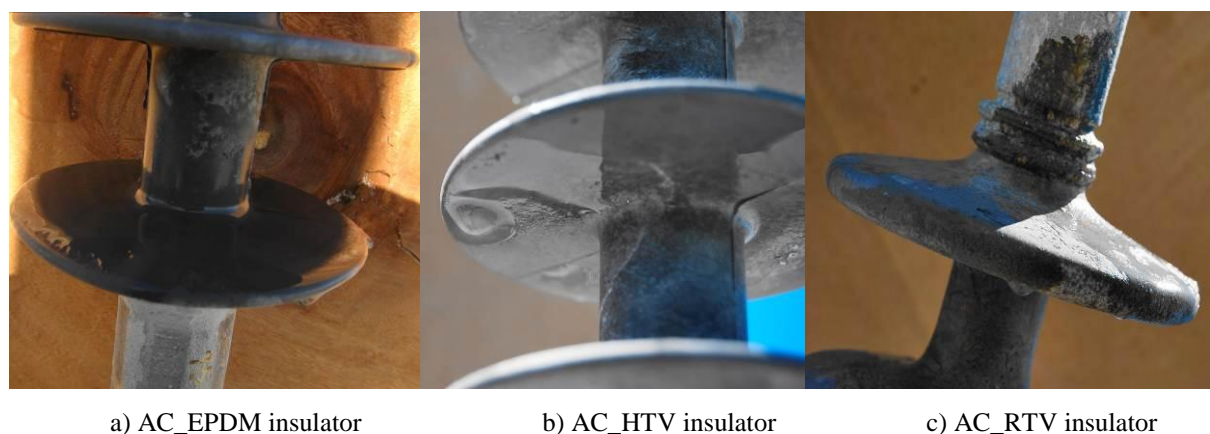
It is evident from Table 5-37 that the AC_EPDM insulator lost its hydrophobicity characteristic the earliest under AC excitation voltage. The AC_EPDM insulator surface was hydrophilic by its first inspection cycle, which was conducted on 7 July 2011. The AC_HTV insulator surface was hydrophilic by its second inspection cycle, which was conducted on 25 August 2011. The AC_RTV insulator surface was hydrophilic by its sixth inspection cycle, which was conducted on 29 November 2011. Please refer to Figure 5-44 for photographs of the hydrophilic state of the polymer insulators under AC excitation voltage.

Figure 5-45: Hydrophilic state of polymer insulators under AC excitation voltage

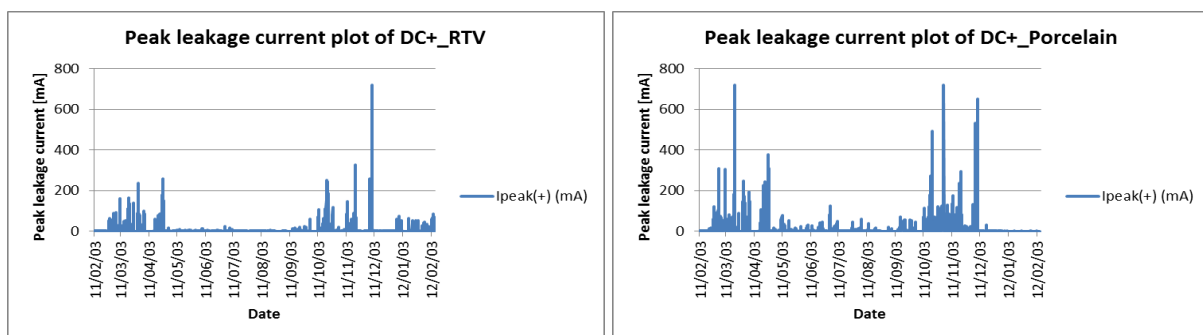
Figure 5-53: Peak leakage current plots of DC+_RTV and DC+_Porcelain insulators

The reason why the AC_Porcelain insulator followed the polymer insulator leakage current trend is not known. It is expected that the AC_Porcelain insulator should follow the DC+_Porcelain and DC-_Porcelain leakage current trends, as seen in Figure 5-53 and Figure 5-55, because porcelain insulators do not have a hydrophobicity characteristic, which requires the insulator surface to age before high leakage currents could flow.

The DC+_RTV and AC_Glass insulators were the only insulators that did not follow the abovementioned pattern as observed in Figure 5-53 and Figure 5-56. It is expected that the DC+_RTV insulator would have isolated leakage current peaks during the early stages of its operational life, yet it had dense leakage current peaks. No explanation could be given to justify the abovementioned behaviour. Furthermore, it is expected that the AC_Glass would have dense leakage current peaks, yet it had isolated leakage current peaks. This can be explained by the clean bottom surface of the glass disc, caused by the deep under ribs on the bottom of the glass insulator, which prevent the pollution from being deposited on it. Furthermore, the AC voltage does not have a strong electrostatic force to pull the charged pollution particles to the bottom surface of the glass disc. The clean bottom surface has a very high resistivity, even when wetted, and therefore the establishment of leakage current paths on the insulator surface happens infrequently, which results in isolated leakage current peaks.

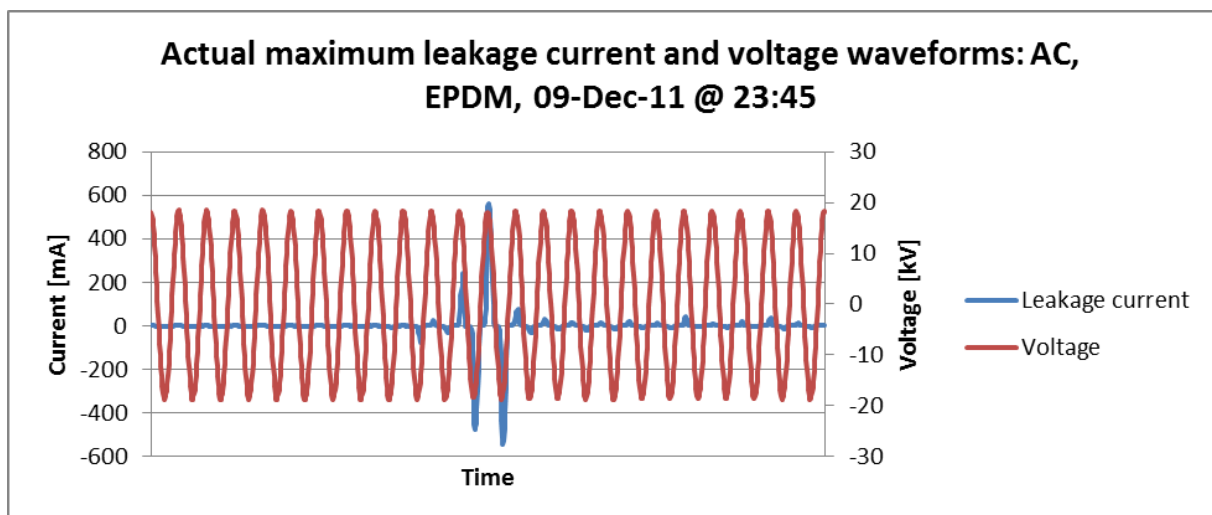
**Figure 5-57: Actual maximum leakage current and voltage waveforms of the AC_EPDM insulator**

It is observed in Figure 5-57 that the AC leakage current has a non-sinusoidal waveform, which implies that the AC leakage current consists of higher harmonic content as well. Furthermore, it should be noted that no fuse explosion activity occurred in this graph.

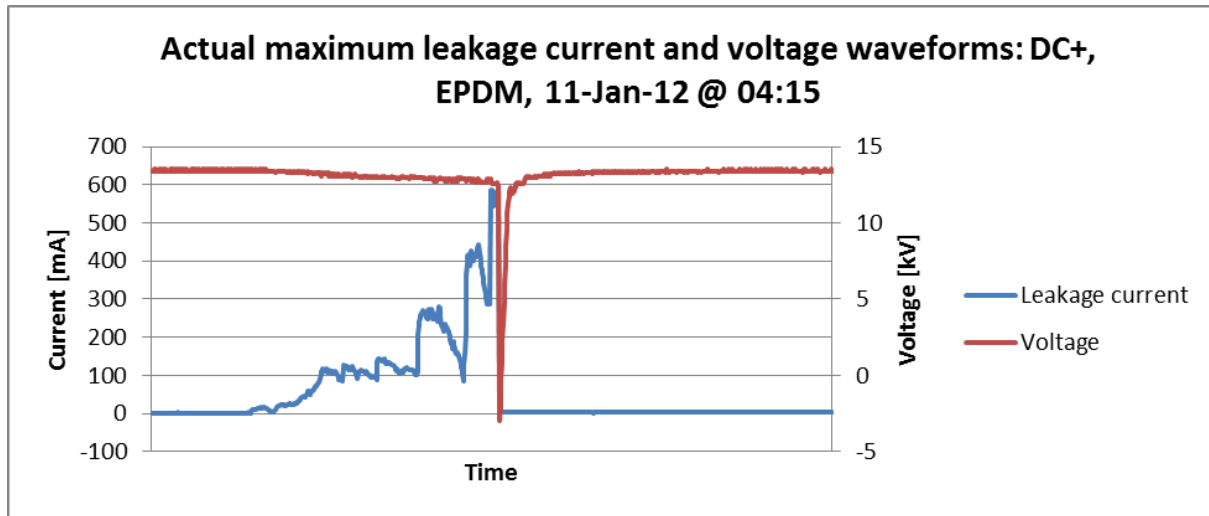
Figure 5-58: Actual maximum leakage current and voltage waveforms of the DC+_EPDM insulator

It is observed in Figure 5-58 that the leakage current of the DC+_EPDM insulator had an approximate linear increase of up to 110 mA and then it became non-linear with very steep increases. The steep increases were small in the beginning of the non-linear portion of the waveform and increase in magnitude closer to the instance when the fuse exploded. It is also observed that the steep increases were followed by approximate linear decreases. The approximate linear increase in the beginning of the graph was caused by the establishment of a leakage current path and an increase of the surface conductivity, which could be caused by continuous wetting of the insulator surface by condensation, deliquescence process, rain drizzle and/or fog. When the leakage current reached a value of approximately 110 mA, as seen in Figure 5-58, the electrolytic conductive layer on the insulator surface vaporizes at the areas with the highest leakage current density, which eventually forms dry bands. It is assumed that there exist multiple leakage current paths on the insulator surface at an instance. Thus, if a dry band forms on one leakage current path, the leakage current flowing on the insulator surface does not necessary reduce to 0 A, but decreases linearly as the conductive layer vaporise. The high voltage differences over the dry bands polarize the air and electrical discharge activities occur which are presented as steep increases in the leakage current plot in Figure 5-58. The small steep increases represent weak electrical discharge activities (small, faint discharges) and the large steep increases represent prominent electrical discharge activities (visible discharges).

In the middle of the graph, the leakage current reduces instantaneously to 0 mA. This happened because the Mace fuse exploded and opened the circuit. The transient response of the smoothing capacitor and the capacitors in parallel with the voltage divider resistors of the AC-to-DC converters reduced the system voltage to -3 kV at the moment at which the fuse exploded, as seen in Figure 5-58. The voltage, then recovers immediately to the value it had before the fuse exploded.

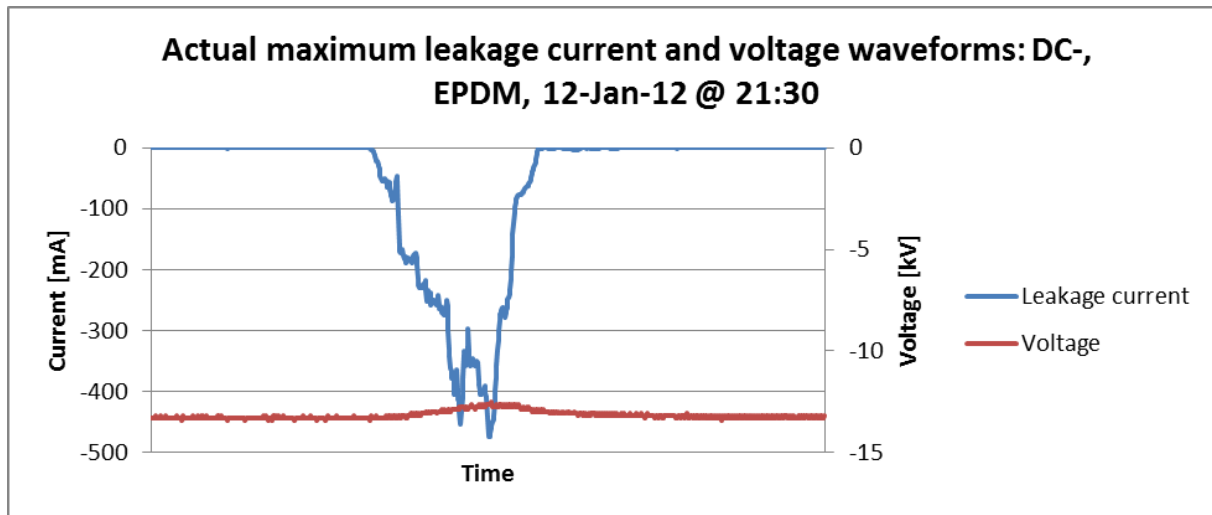
Figure 5-59: Actual maximum leakage current and voltage waveforms of the DC-EPDM insulator

It is observed in Figure 5-59 that the leakage current of the DC-EPDM insulator had an approximate linear waveform up to -90 mA and then it became non-linear with very steep decreases. The steep decreases were large in the beginning of the non-linear portion of the waveform, and nearby the maximum negative leakage current peak. Furthermore, it is small in the middle section between the beginning of the non-linear portion and the maximum negative leakage current peak. The steep decreases were caused by electrical discharge activities, where the small steep decreases represent weak electrical discharge activity (small, faint discharges) and the large steep decreases represent prominent electrical discharge activities (visible discharges). The steep increases in the graph represent the extinguished electrical discharge activities. Close to the end of the graph it is observed that the non-linear part of the graph ends at approximately -90 mA and increases approximately linearly to 0 mA. The approximate linear increase to 0 mA represents the drying of the leakage current path through evaporation. Furthermore, it should be noted that no fuse explosion activity occurred in this graph.

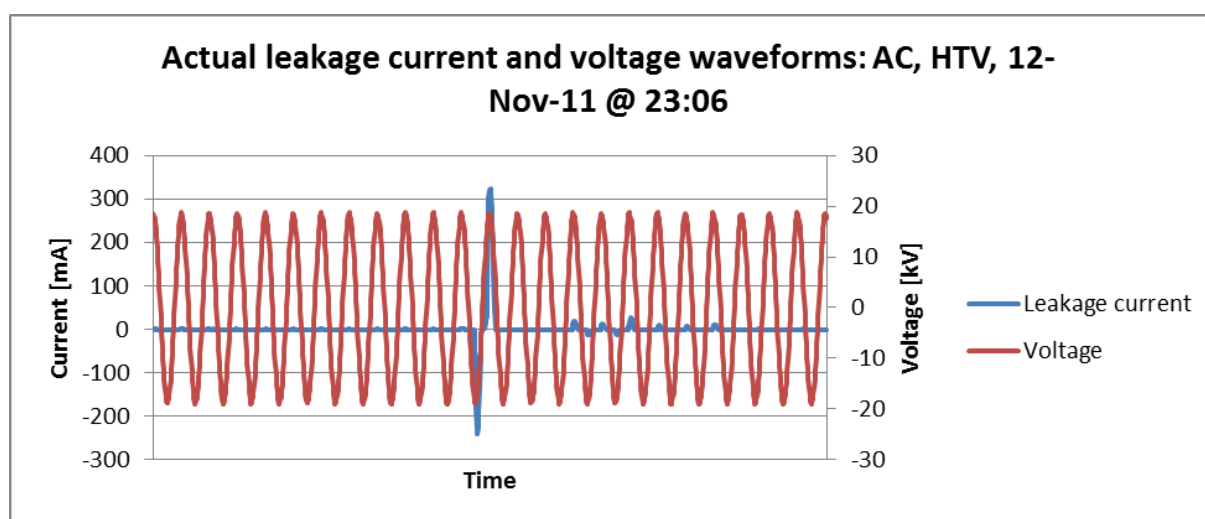
Figure 5-60: Actual leakage current and voltage waveforms of AC_HTV insulator

It is observed in Figure 5-60 that the AC leakage current has a non-sinusoidal waveform, which implies that the AC leakage current consists of higher harmonic content as well. Furthermore, it should be noted that no fuse explosion activity occurred in this graph. It should be noted that the leakage current waveform in Figure 5-60 is not the waveform of the maximum absolute peak leakage current value recorded for the AC_HTV insulator, but the second highest. The actual leakage current waveform of the maximum absolute peak leakage current value was not stored on the OLCA.

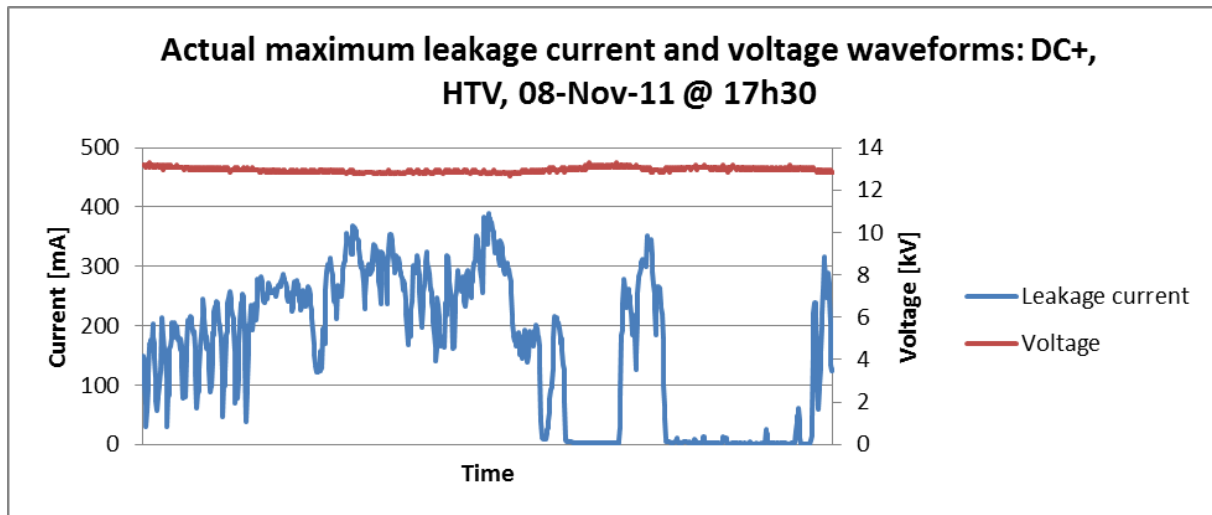
Figure 5-61: Actual maximum leakage current and voltage waveforms of the DC+_HTV insulator

It is observed in Figure 5-61 that the leakage current waveform of the DC+_HTV insulator is non-linear with very steep increases and decreases. The steep increases in the leakage current are caused by electrical discharge activities. The small step increases represent weak electrical discharge activity (small, faint discharges) and the large step increases represent prominent electrical discharge activities (visible discharges). The step decreases represent extinguished electrical discharge activities. The leakage current waveform in Figure 5-61 is mostly characterized by large step increases and decreases, thus visible discharges. Furthermore, it should be noted that no fuse explosion activity occurred in this graph.

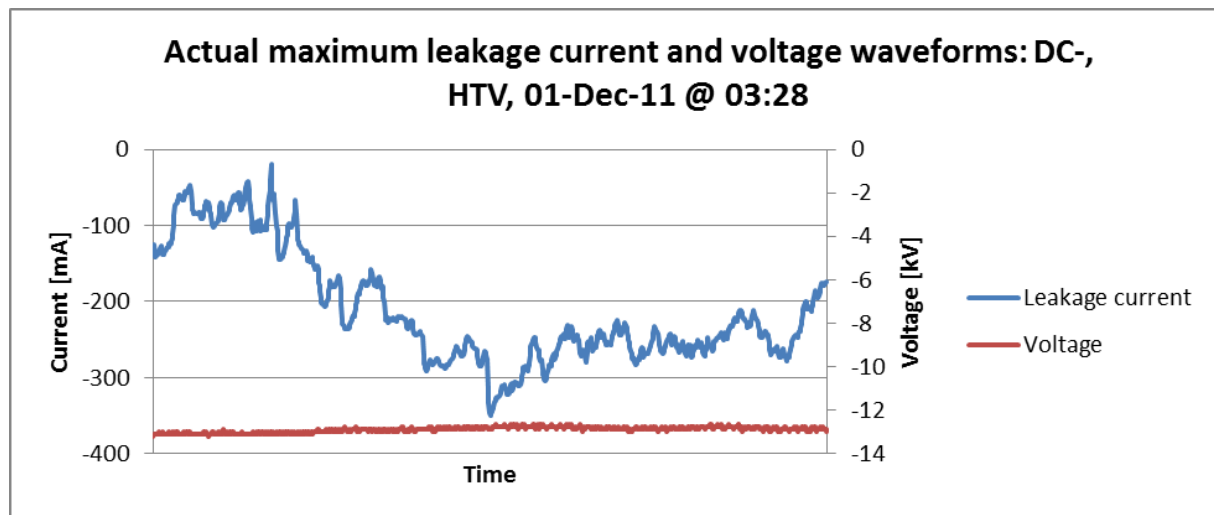
Figure 5-62: Actual maximum leakage current and voltage waveforms of the DC-_HTV insulator

It is observed in Figure 5-62 that the leakage current waveform of the DC-_HTV insulator is non-linear with very steep increases and decreases. The steep decreases in the leakage current are caused by electrical discharge activities. The small step decreases represent weak electrical discharge activity (small, faint discharges) and the large step decreases represent prominent electrical discharge activities (visible discharges). The step increases represent extinguished electrical discharge activities. The leakage current waveform in Figure 5-62 is mostly characterized by small step increases and decreases, thus small, faint discharges. Furthermore, it should be noted that no fuse explosion activity occurred in this graph.

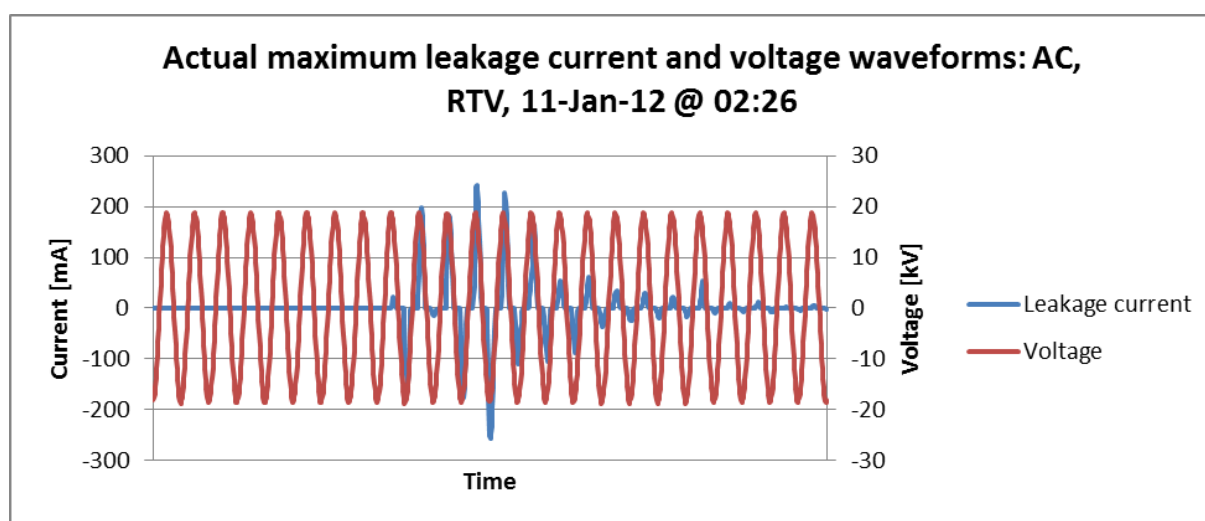
Figure 5-63: Actual maximum leakage current and voltage waveforms of the AC_RTU insulator

It is observed in Figure 5-63 that the AC leakage current has a non-sinusoidal waveform, which implies that the AC leakage current consists of higher harmonic content as well. Furthermore, it should be noted that no fuse explosion activity occurred in this graph.

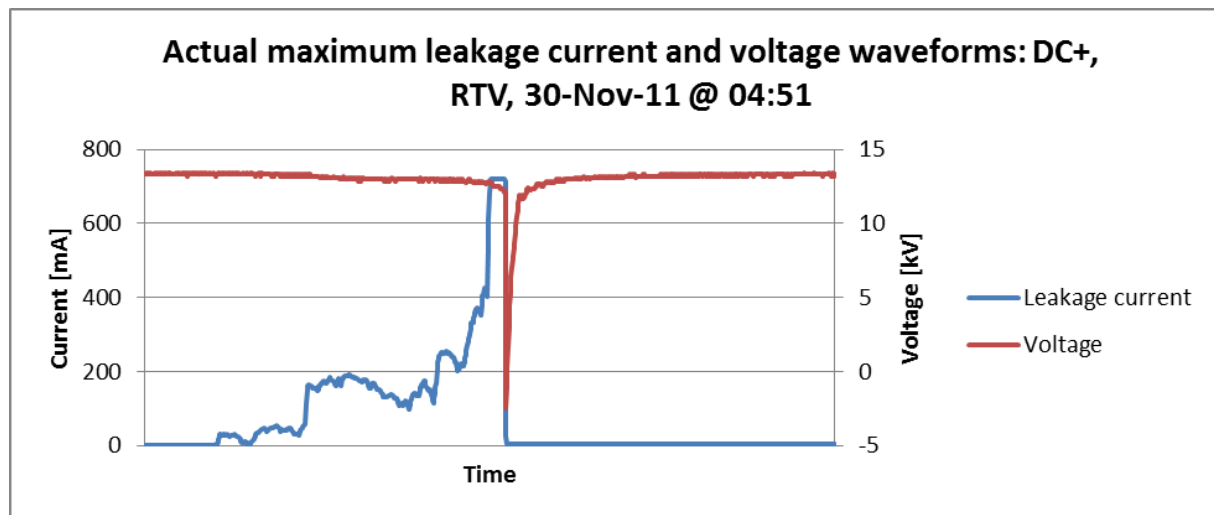
Figure 5-64: Actual maximum leakage current and voltage waveforms of the DC+_RTV insulator

It is observed in Figure 5-64 that the leakage current of the DC+_RTV insulator is non-linear with very steep increases and decreases. The steep increases were small in the beginning of the waveform and it became larger close to the instance when the fuse exploded. The steep increases in the leakage current as observed in Figure 5-64 were caused by electrical discharge activities. The small steep increases represent weak electrical discharge activity (small, faint discharges) and the large steep increases represent prominent electrical discharge activities (visible discharges).

In the middle of the graph the maximum peak leakage current saturated at 719.8 mA and then reduced instantaneously to 0 mA. This happened because the Mace fuse exploded and opened the circuit. The transient response of the smoothing capacitor and the capacitors in parallel with the voltage divider resistors of the AC-to-DC converters reduced the system voltage to -3 kV at the moment the fuse exploded as seen in Figure 5-64. The voltage then immediately recovers to the value it had prior the explosion of the fuse.

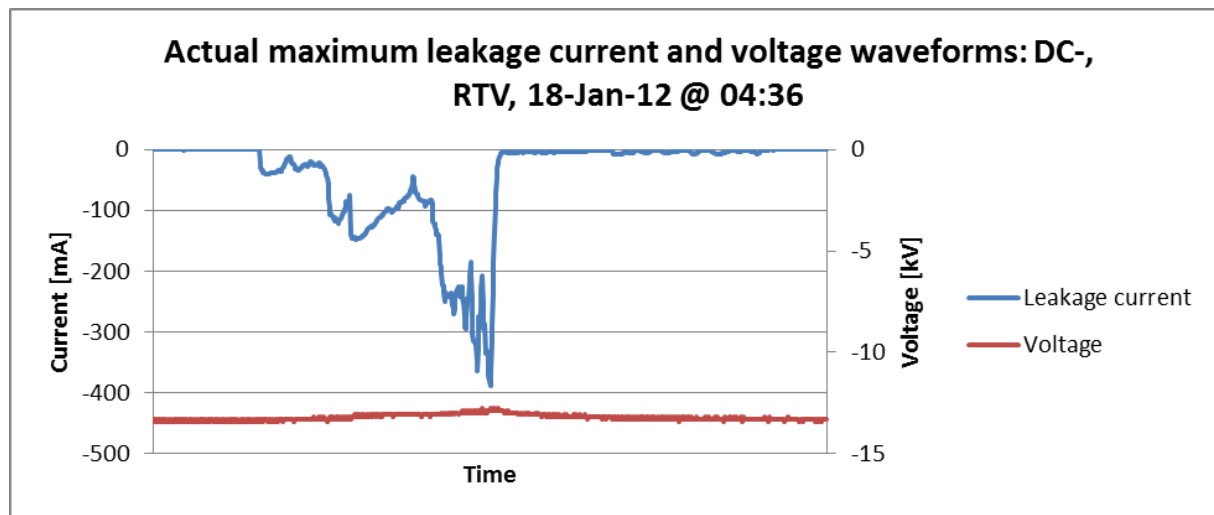
Figure 5-65: Actual maximum leakage current and voltage waveforms of the DC-_RTV insulator

It is observed in Figure 5-65 that the leakage current of the DC-_RTV insulator is non-linear with very steep decreases and increases. The steep decreases were small in the beginning of the waveform and large close to the maximum negative leakage current peak. The steep decreases in the leakage current were caused by electrical discharge activity. The small steep decreases represent weak electrical discharge activity (small, faint discharges) and the large steep decreases represent prominent electrical discharge activities (visible discharges). The steep increases in the graph represent the extinguished electrical discharge activities. Furthermore, it should be noted that no fuse explosion activity occurred in this graph.

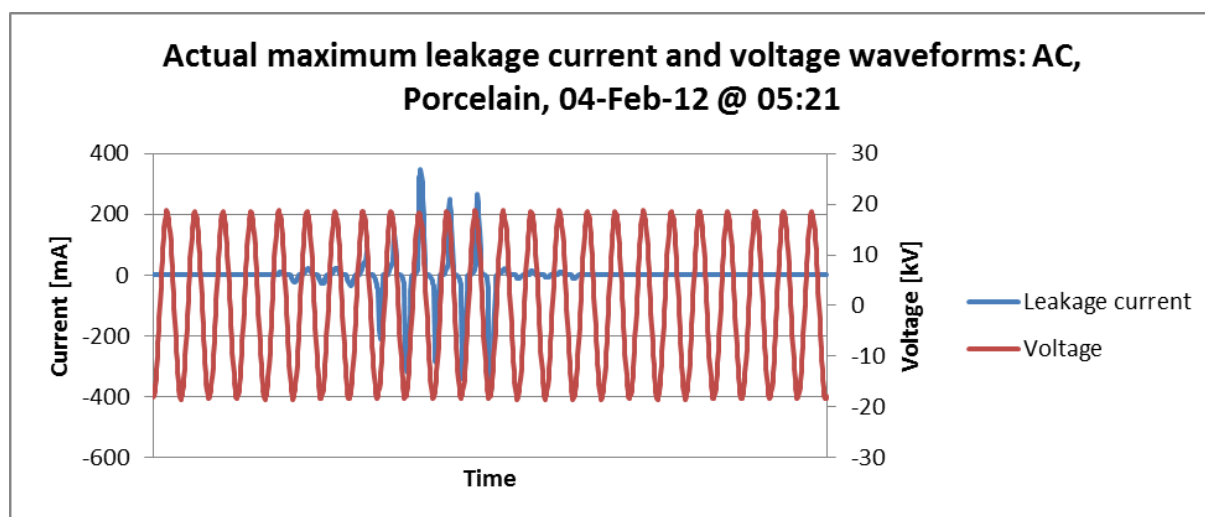
Figure 5-66: Actual maximum leakage current and voltage waveforms of the AC_Porcelain insulator

It is observed in Figure 5-66 that the AC leakage current has a non-sinusoidal waveform, which implies that the AC leakage current consists of higher harmonic content as well. Furthermore, it should be noted that no fuse explosion activity occurred in this graph.
